Re: Notice of Violation  
Reserve at Alaquia Subdivision  
National Pollutant Discharge Elimination System Permit No.: FLR100000  
Identification Number: FLR10NV66

U.S. Environmental Protection Agency, Region 4  
61 Forsyth Street SW, Atlanta, GA 30303  
**Water Compliance Inspection Report**

### Standard Pacific's The Reserve at Alaqua Stormwater Inspection FLR10NV66

March 25, 2015  
US EPA - Region 4

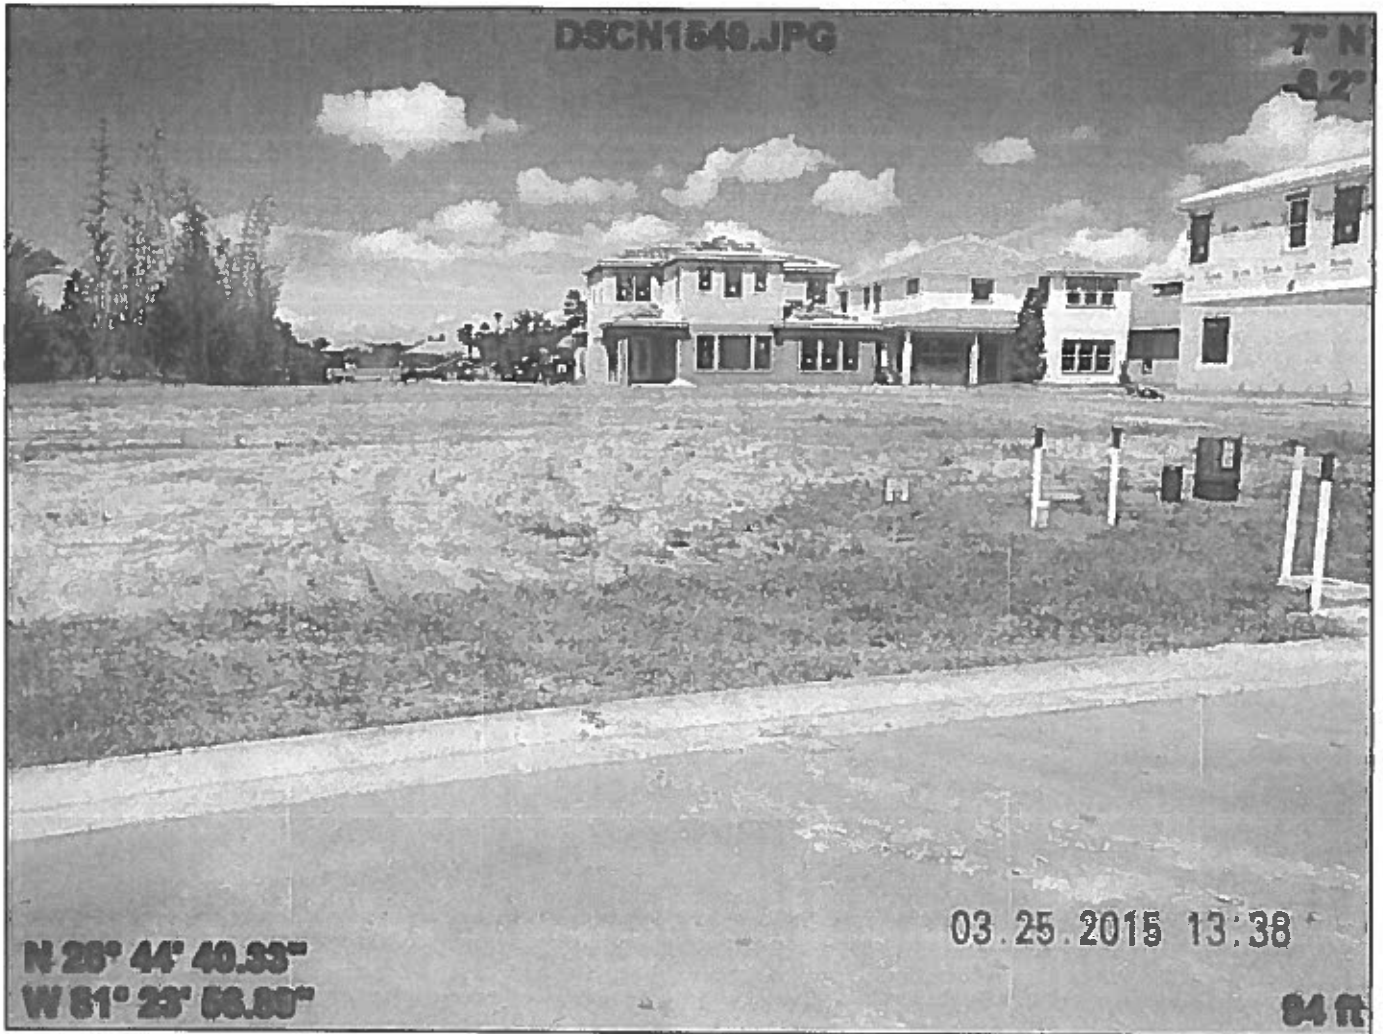
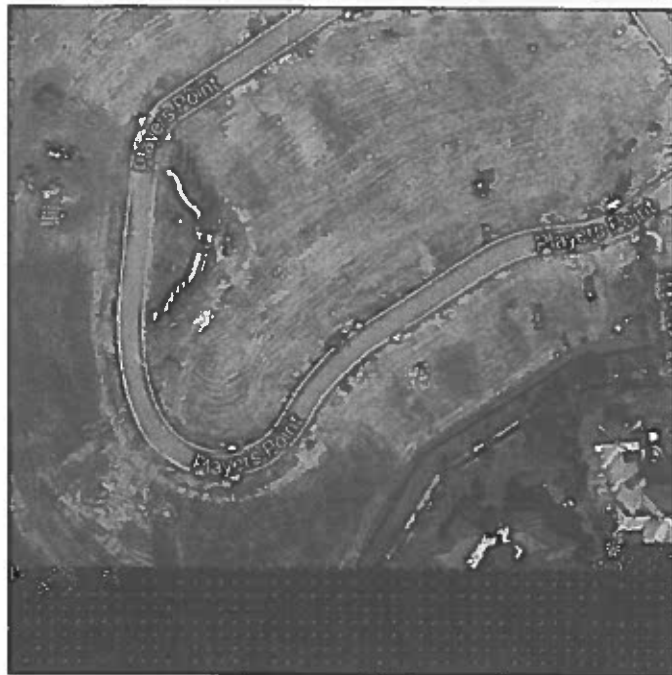
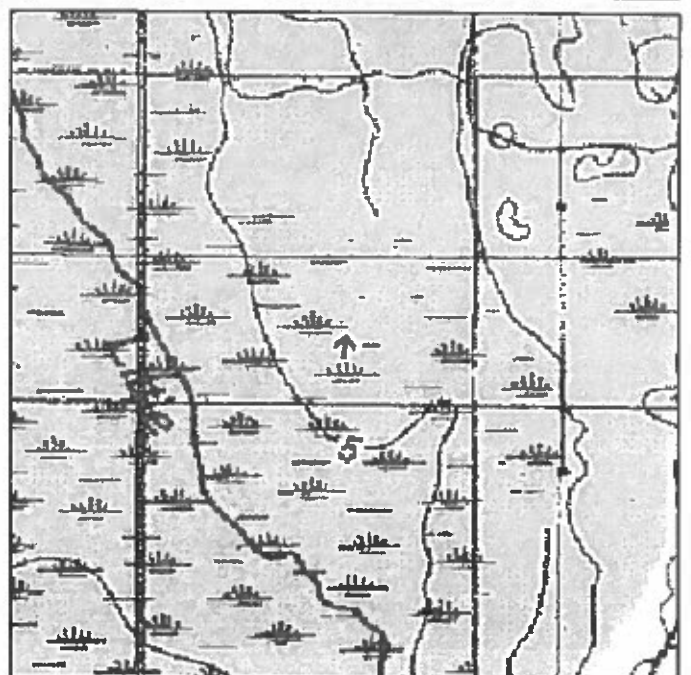
1. There were un-stabilized areas and improper curb best management practices on Lot #12, 34, adjacent to #32, 29, near #26, and 19. See Photo DSCN1549, 1551, 1552, 1553, 1554, 1557, and 1558. Stabilization measures shall be initiated as soon as practicable, but in no case more than 7 days, in portions of the site where construction activities have temporarily or permanently ceased.

2. There was evidence of vehicle tracking in front of Lot #12 and 16. See Photo DSCN1549 and DSCN1556. BMPs, practices or measures identified in the SWPPP shall be performed in a timely manner, but in no case later than 7 calendar days.

Description: undeveloped lot with un-stabilized areas, vehicle tracking at Lot #12.

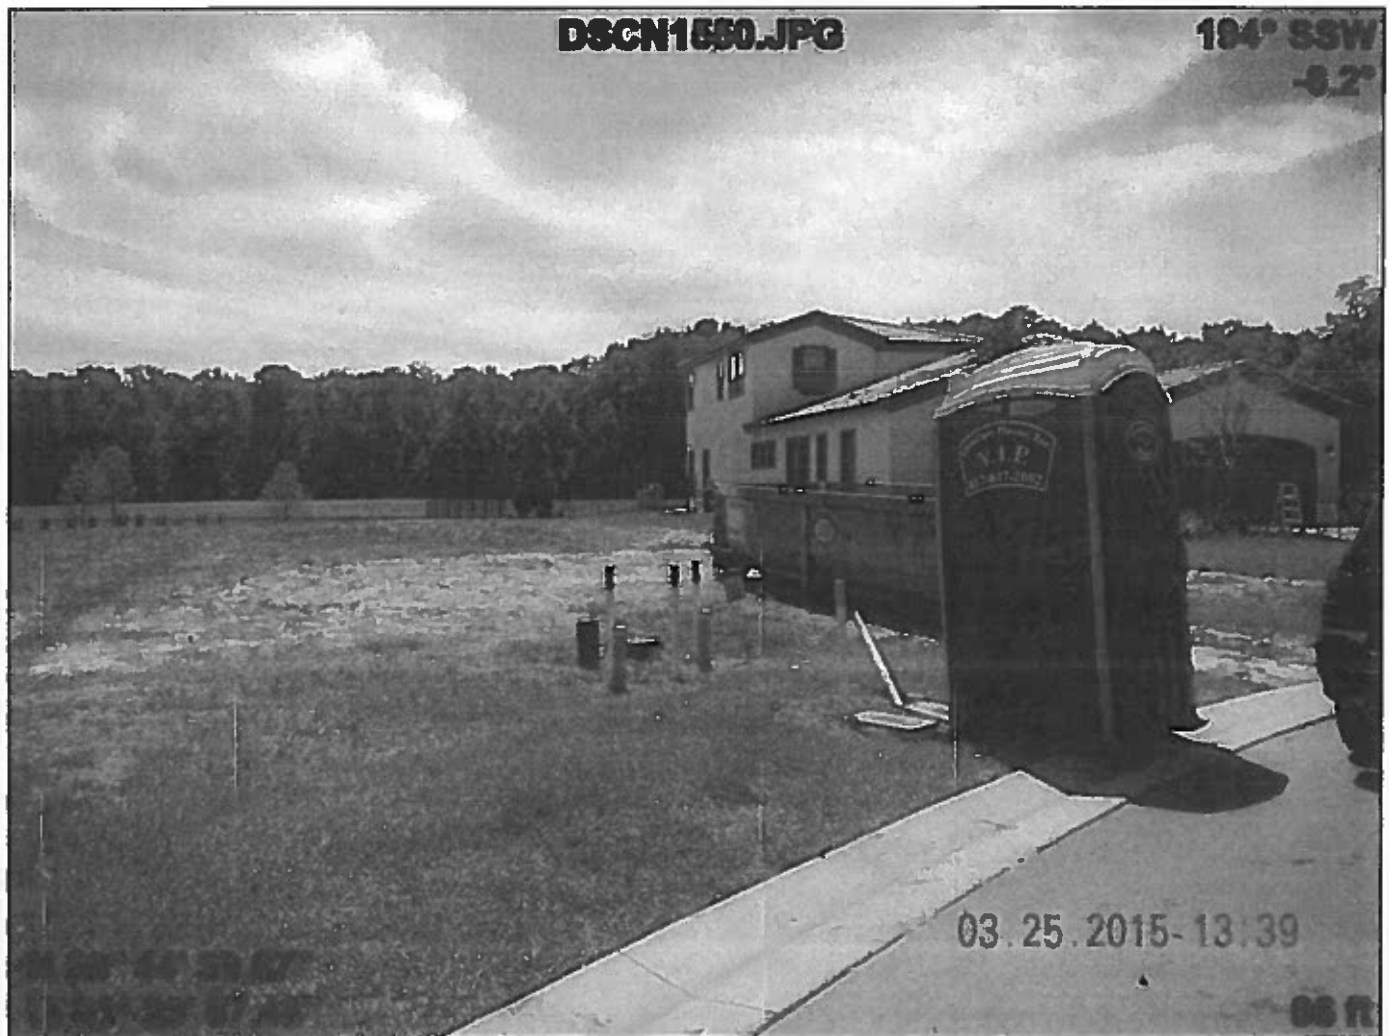
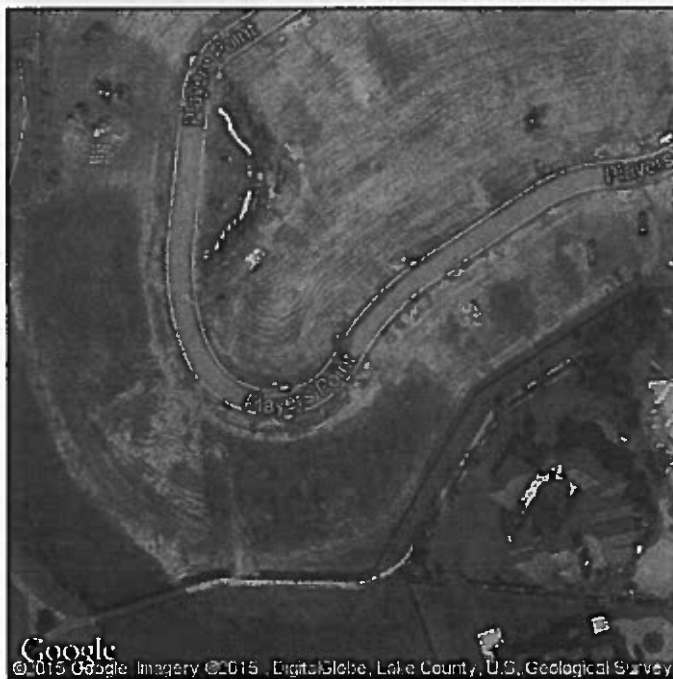
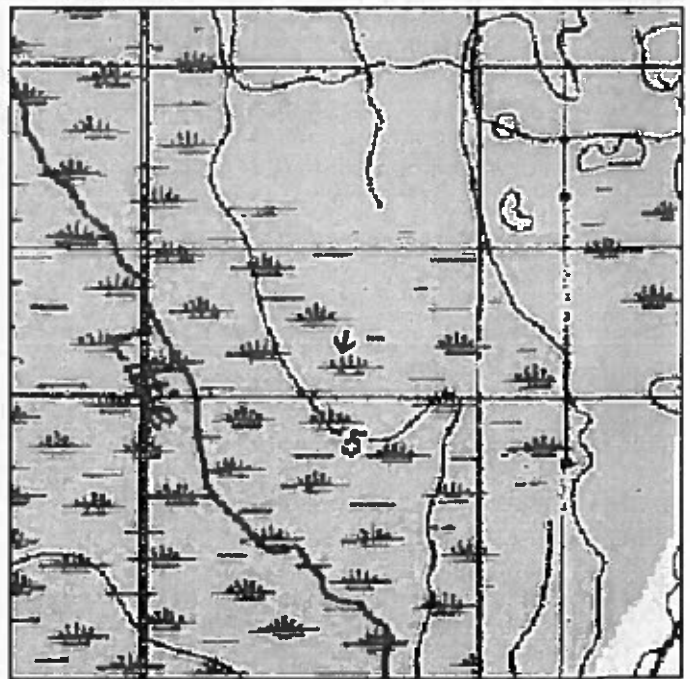
3. *Part V.A of the Permit: "A stormwater pollution prevention plan shall be ...implemented for each construction site covered by this permit."*
  - a. At the time of inspection, portable toilets were less than 5 feet from curb at Lot #37 (Photo DSCN1550), Lot #16 (Photo DSCN1555, 1556), and Lot #21 (Photo DSCN1559). The SWPPP requires that the portable toilet be located at least 5 feet from the curb.

Description: portable toilet location within 5 feet of curb at Lot#37.

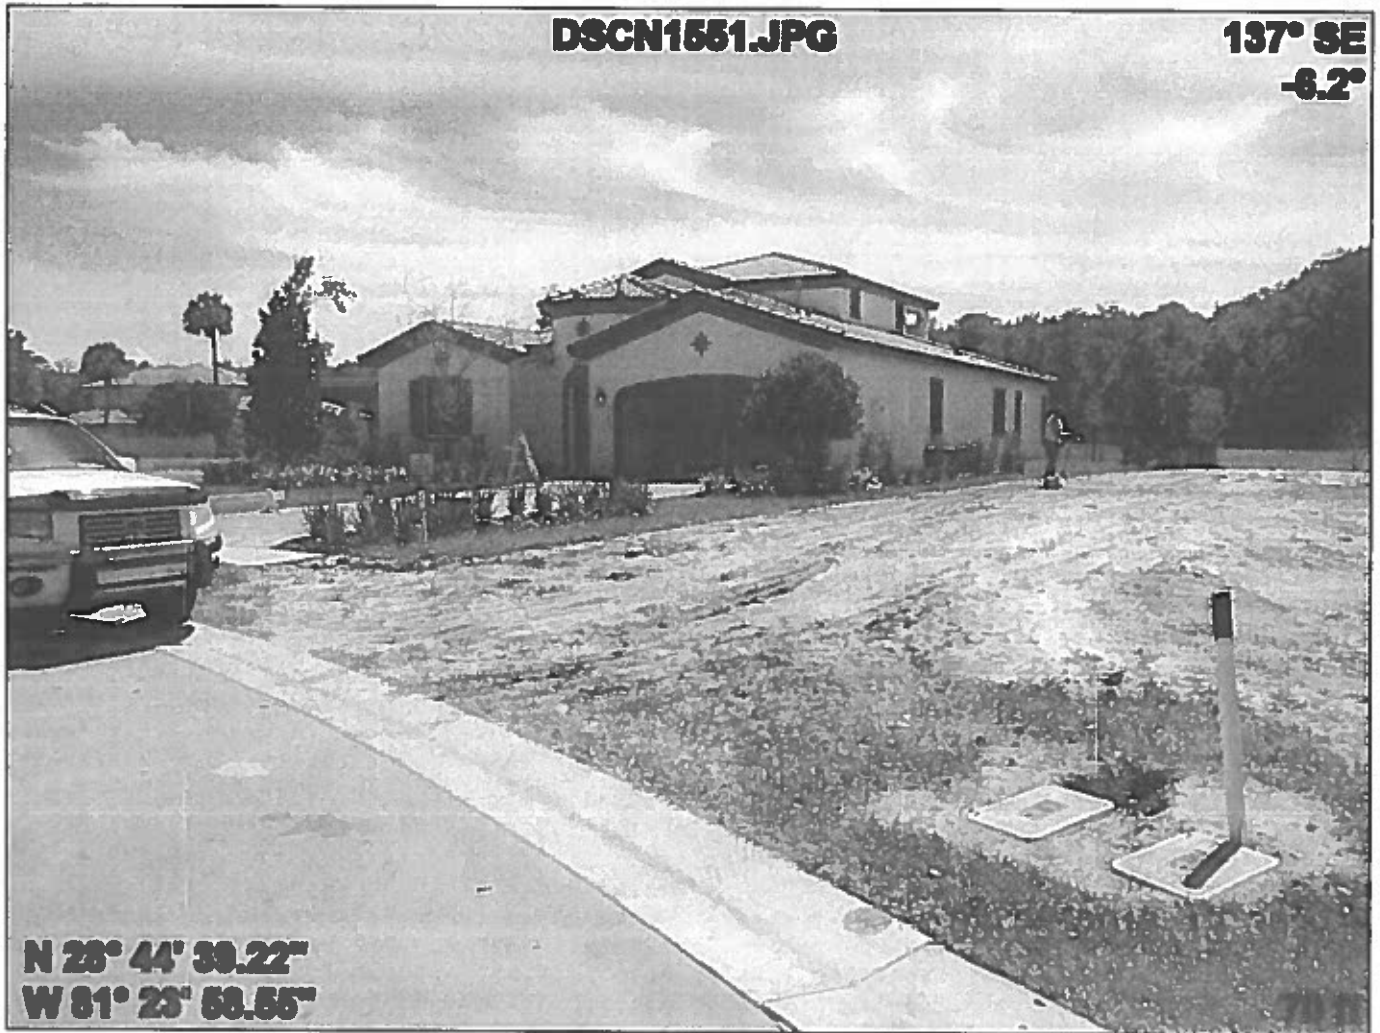
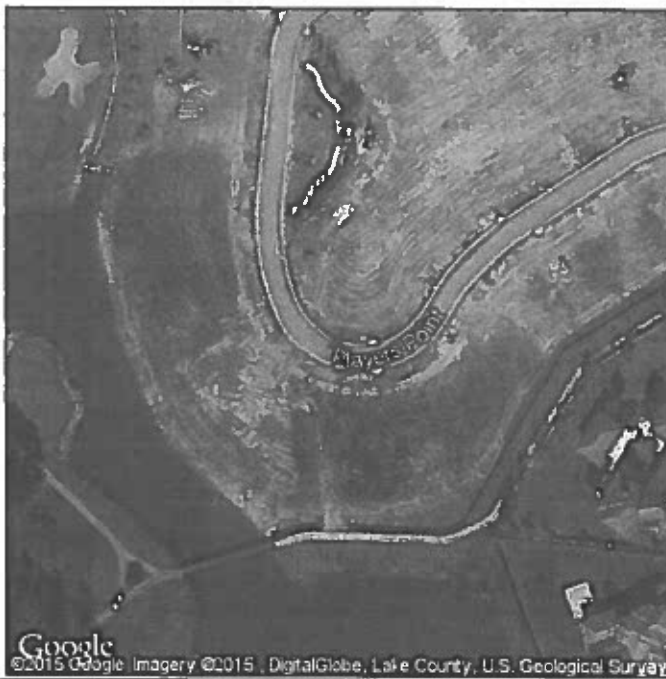
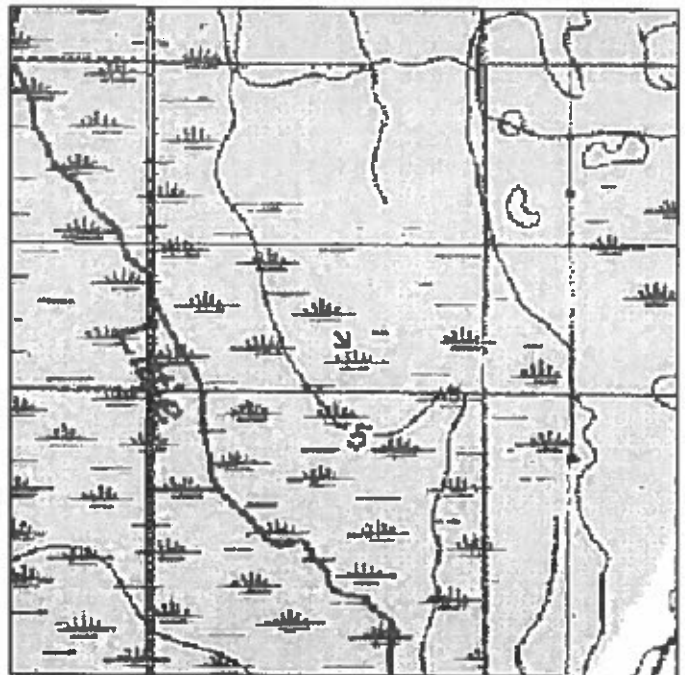
1. *Part V.D.2.c.(5) of the Permit: "The plan shall ensure that the application, generation and migration of toxic substances are limited and that toxic materials are properly stored and disposed."*
  - a. At the time of inspection, paint and paint washing were improperly disposed of on the lot adjacent to Lot #34. See Photo DSCN1551. The Stormwater Pollution Prevention Plan (SWPPP) specifies Lot #44 for the location of paint washouts.

Description: paint washout activity, un-stabilized areas, lack curb BMP at Lot#34.

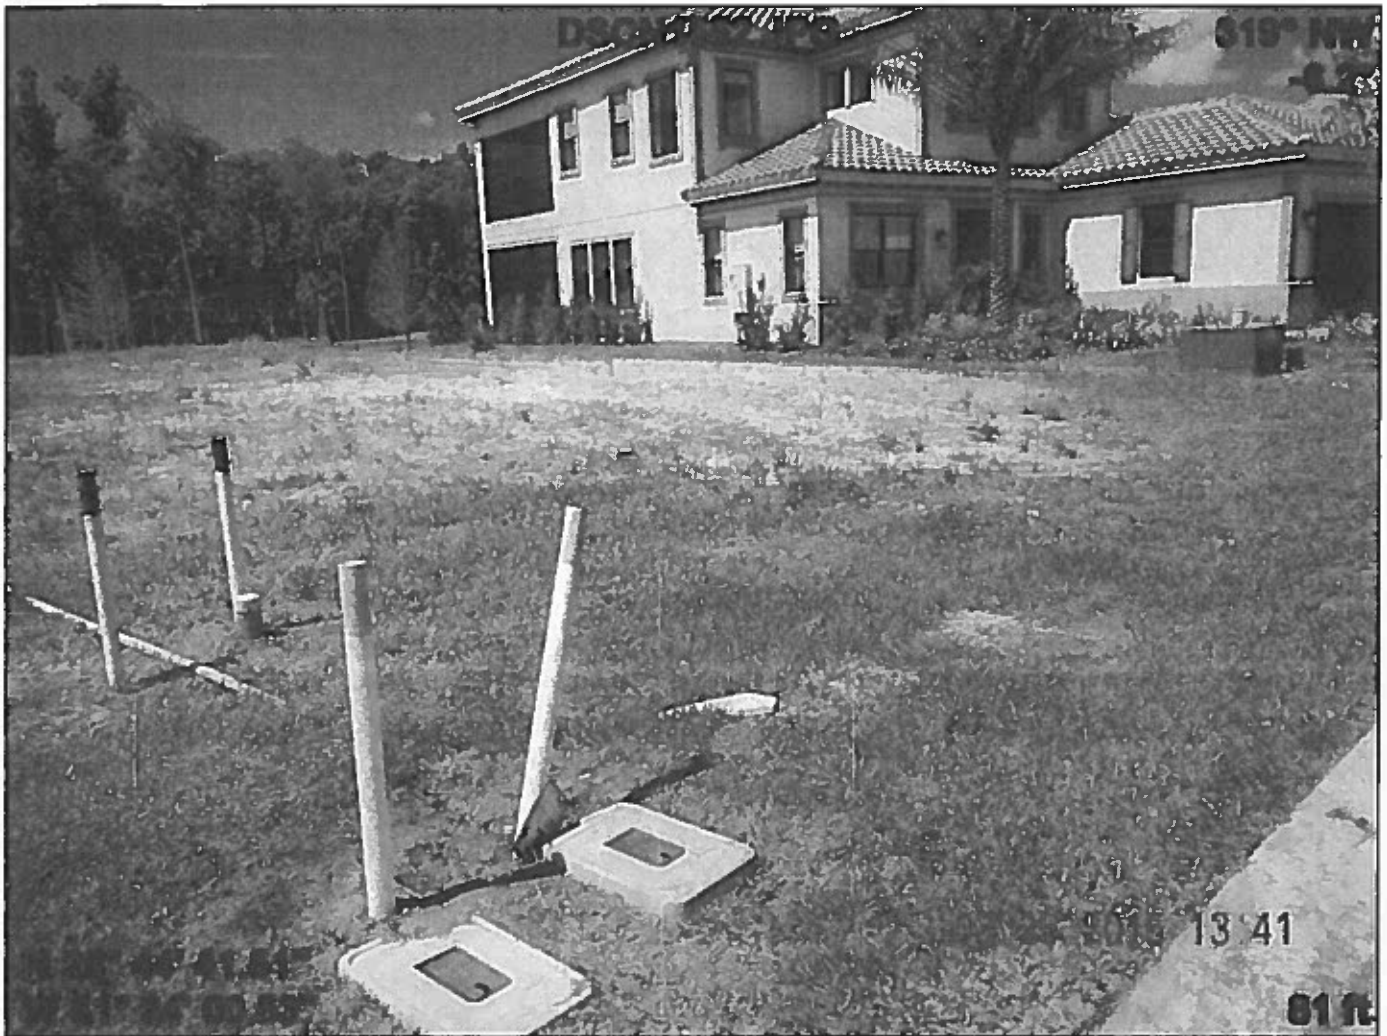
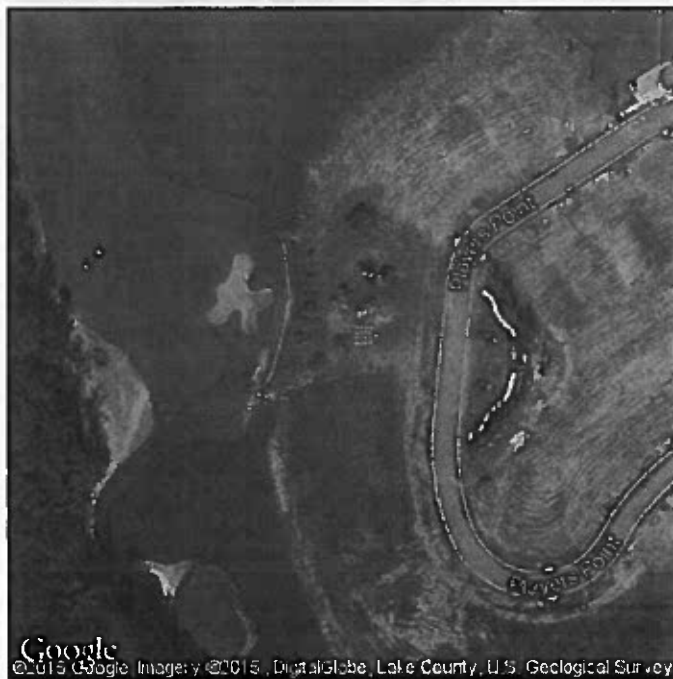
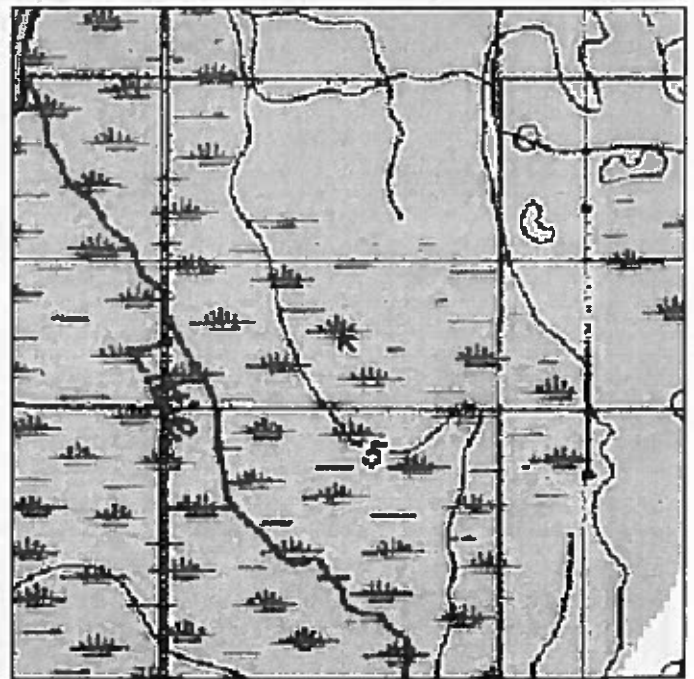
Description: undeveloped lot with un-stablized areas next to Lot #32.

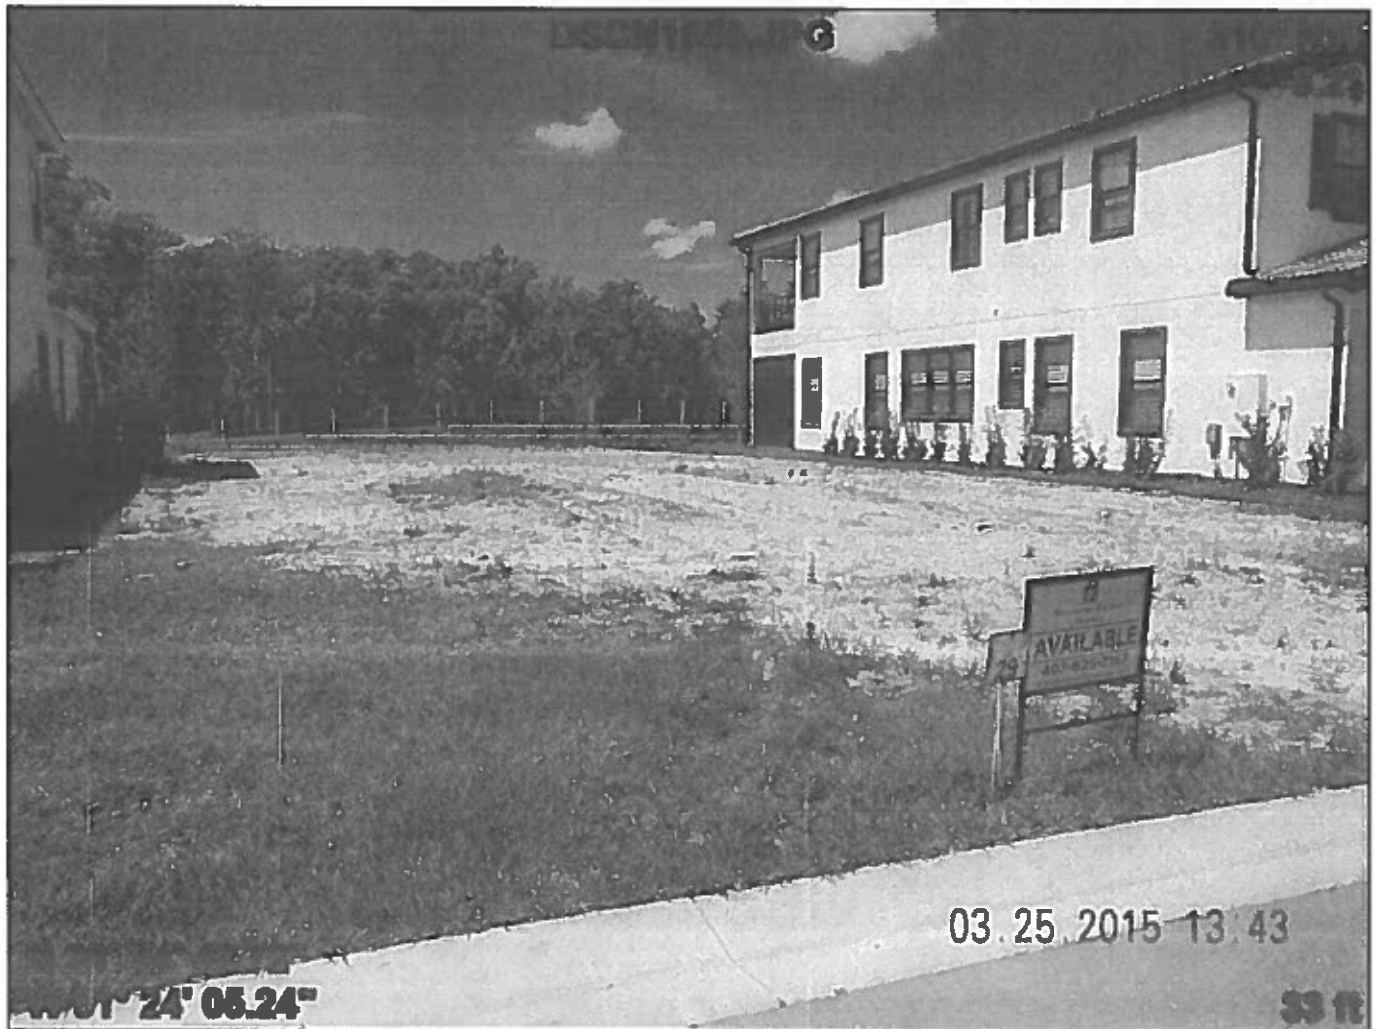
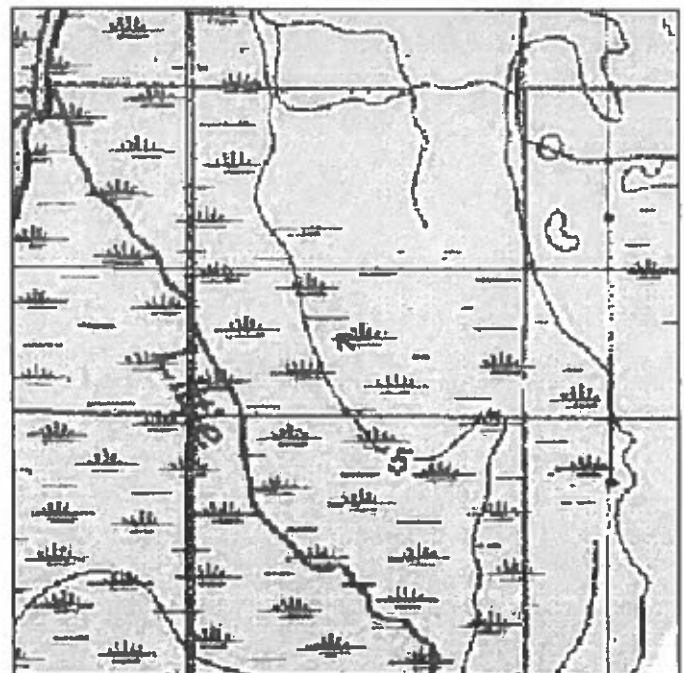
Description: undeveloped lot with un-stablized areas at Lot #29.

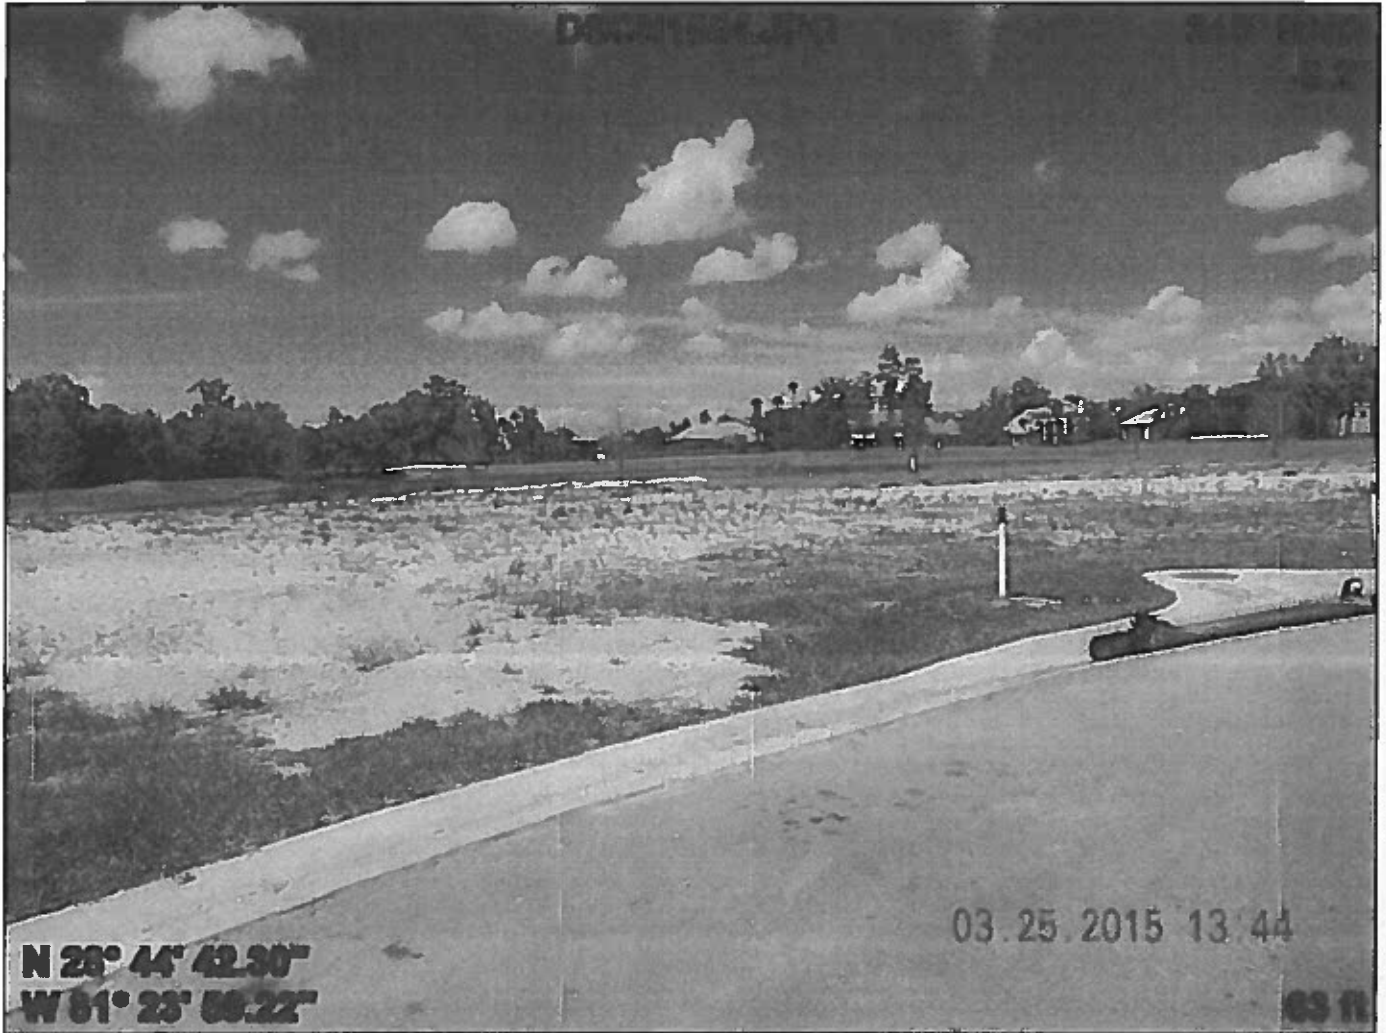
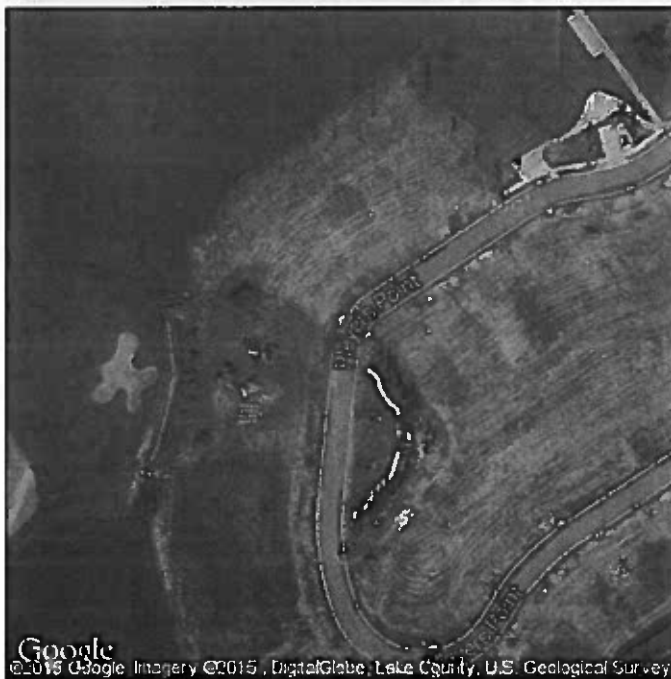
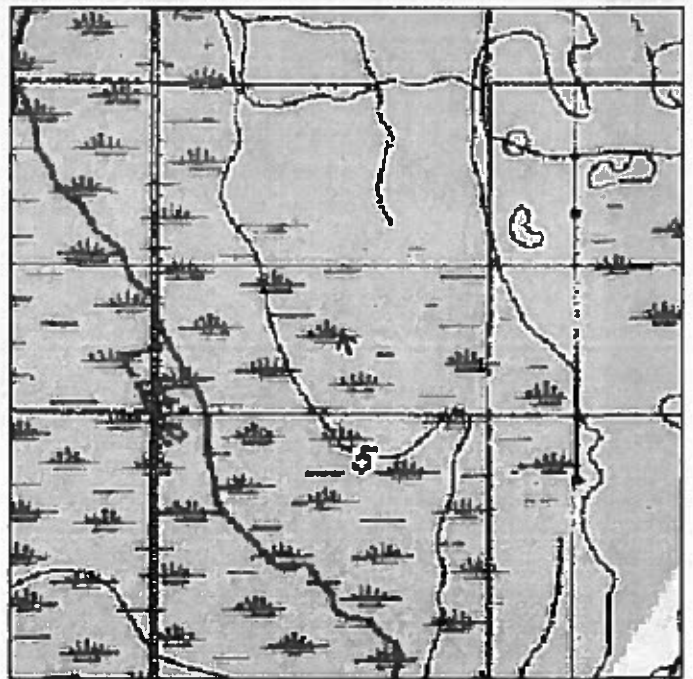
Description: undeveloped area with up-stabilized areas near Lot #26.

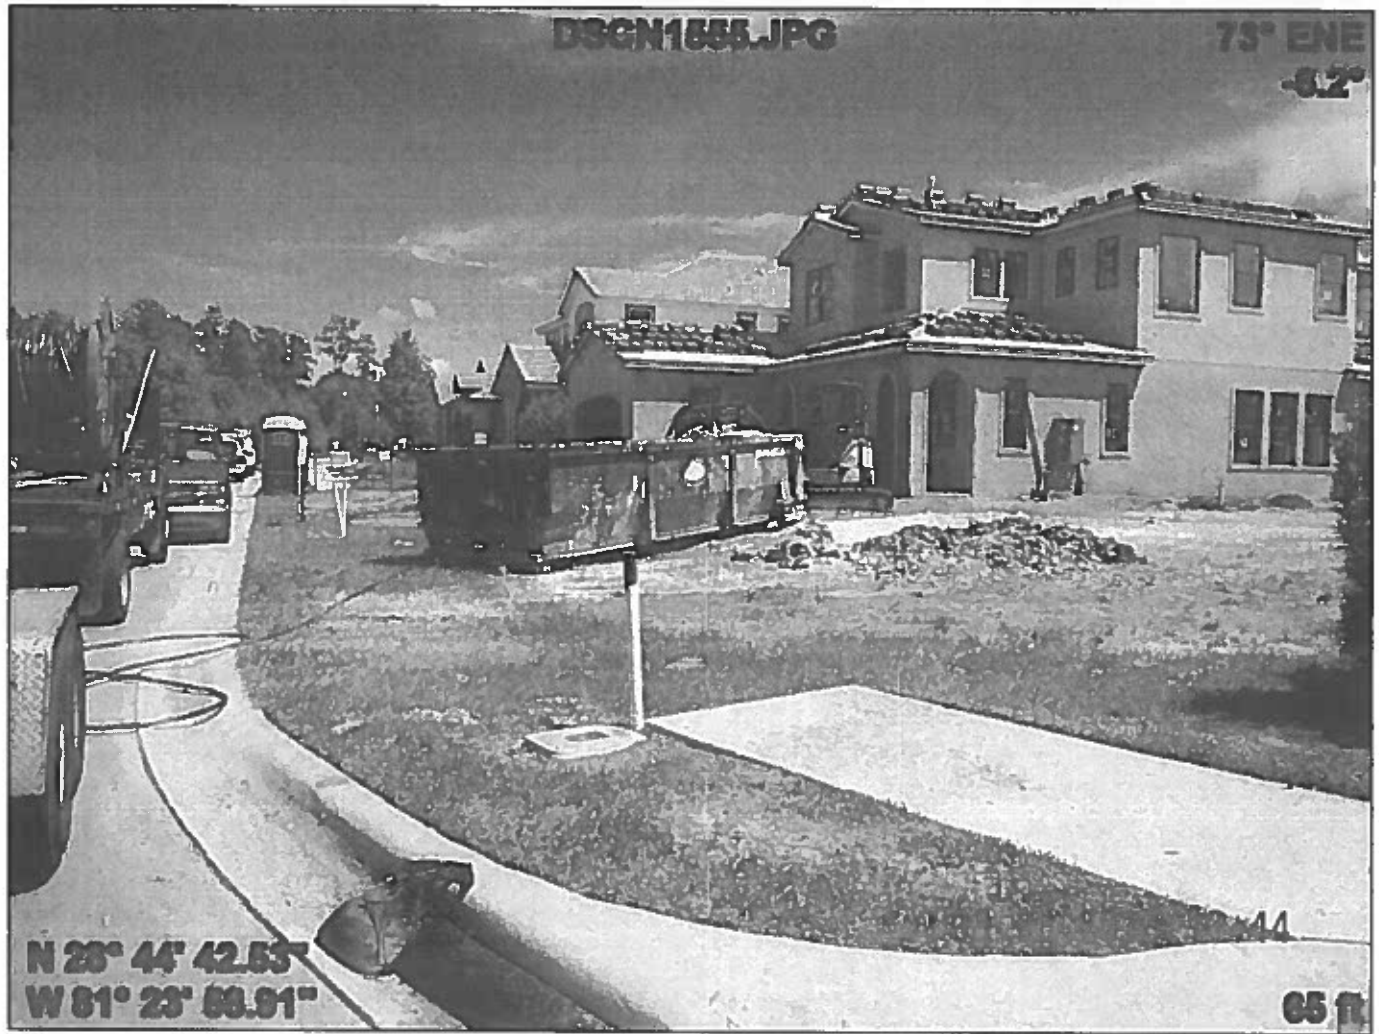
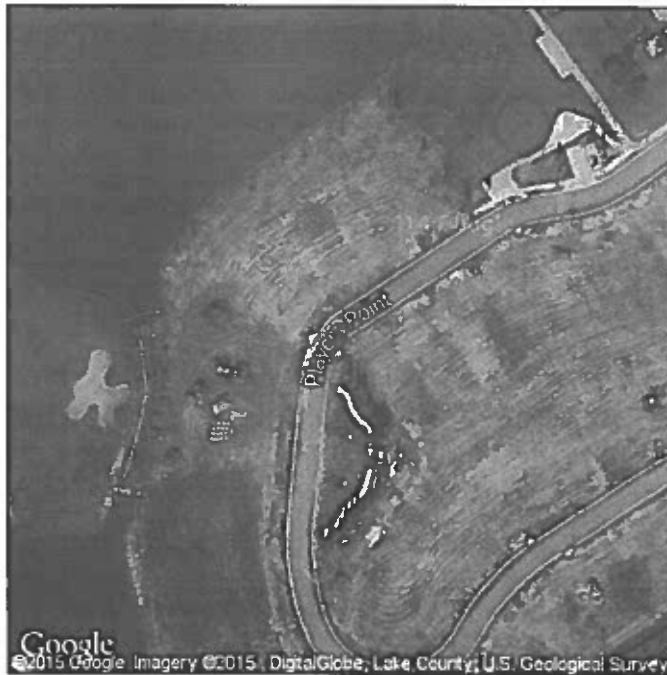
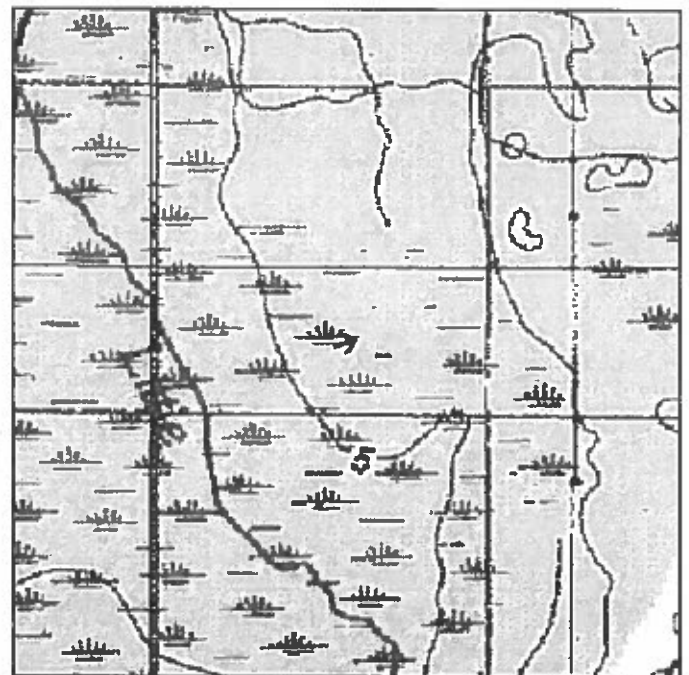
- b. At the time of inspection, there was evidence of a concrete washout at Lot #16. See Photo DSCN1555 and 1556. The SWPPP designated Lot#44 as the concrete washout location.

Description: portable toilet located within 5 feet of curb. Vehicle tracking and concrete washout from Lot #16.

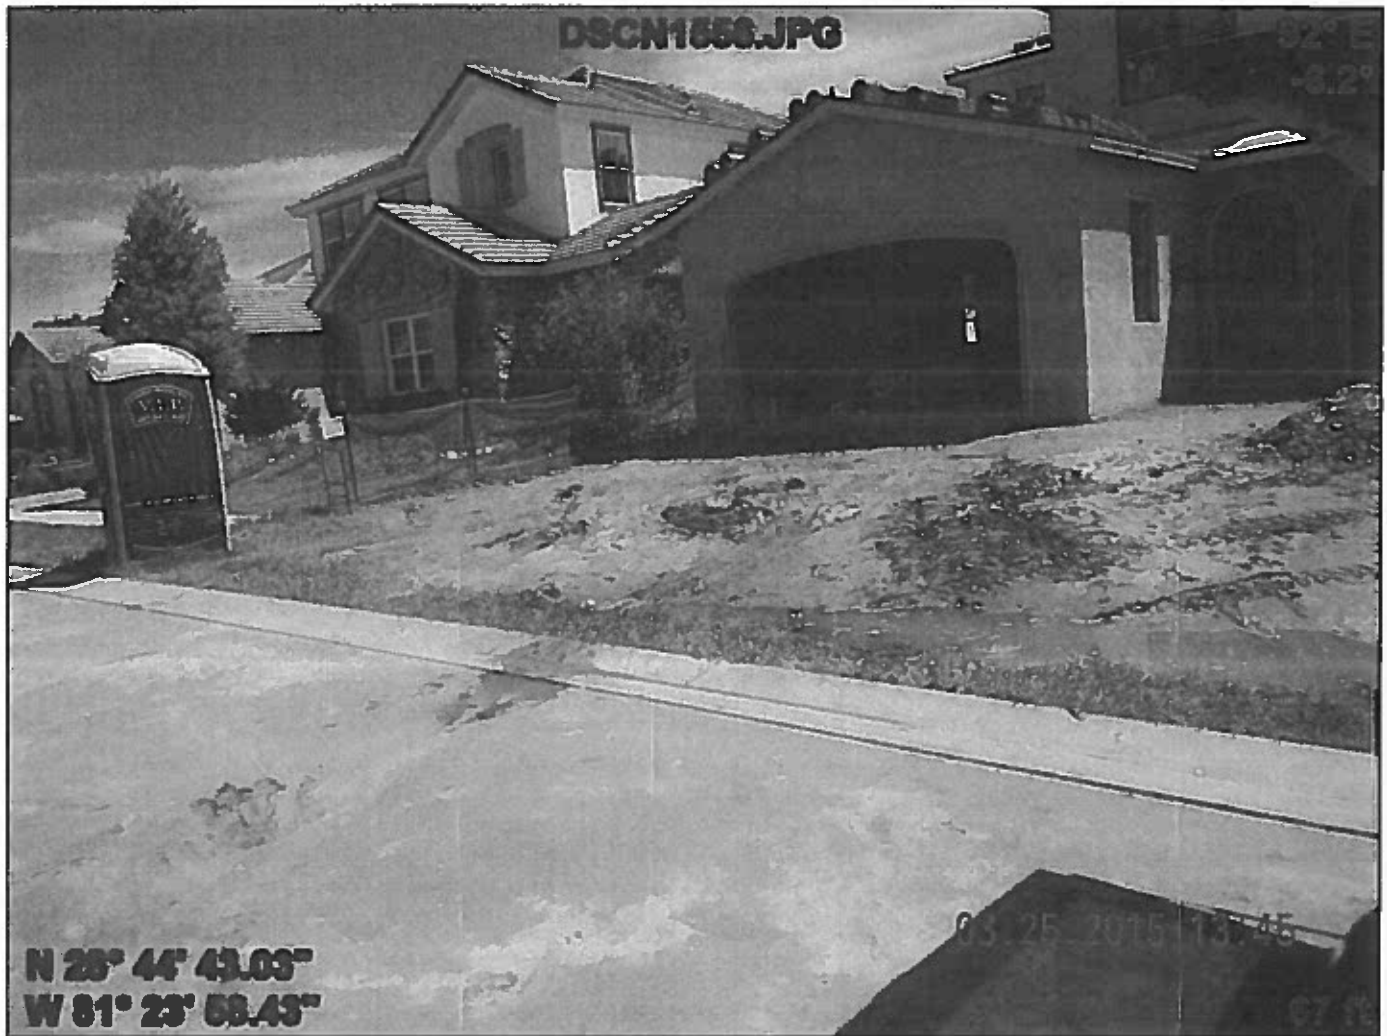
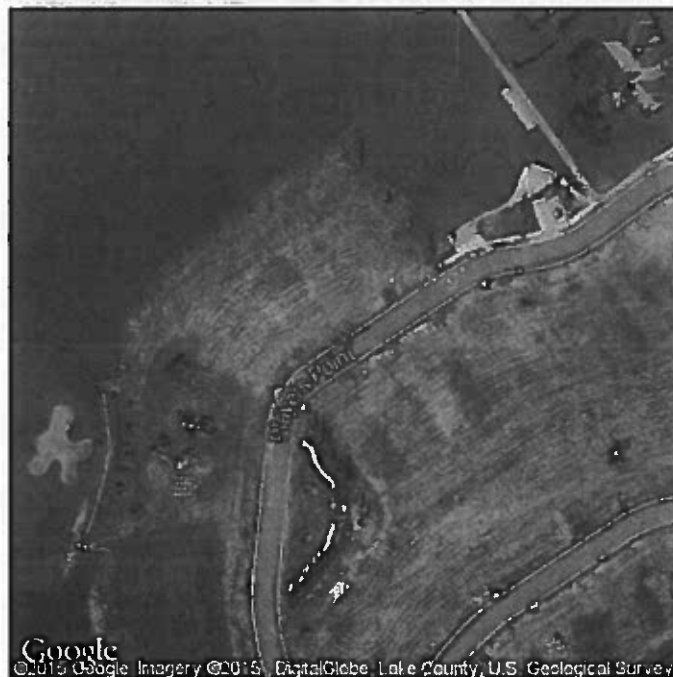
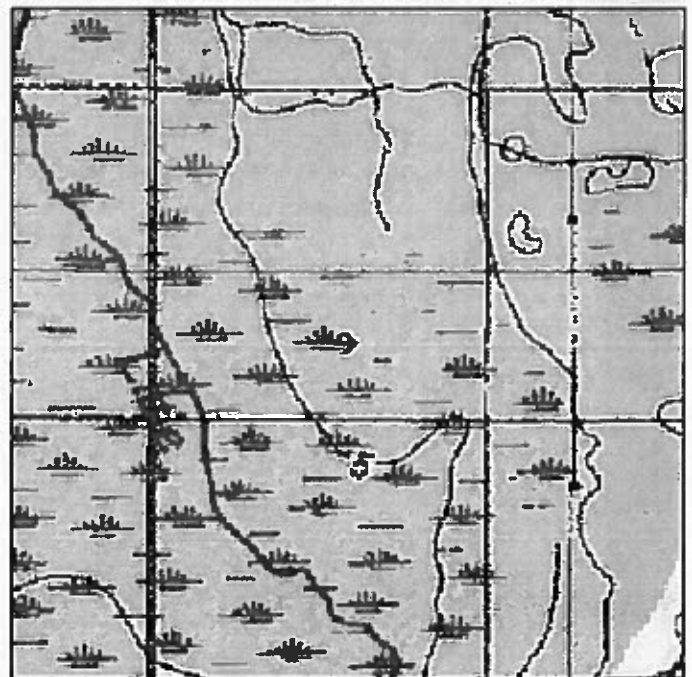
Description: portable toilet located within 5 feet of curb. Vehicle tracking and concrete washout from Lot #116.

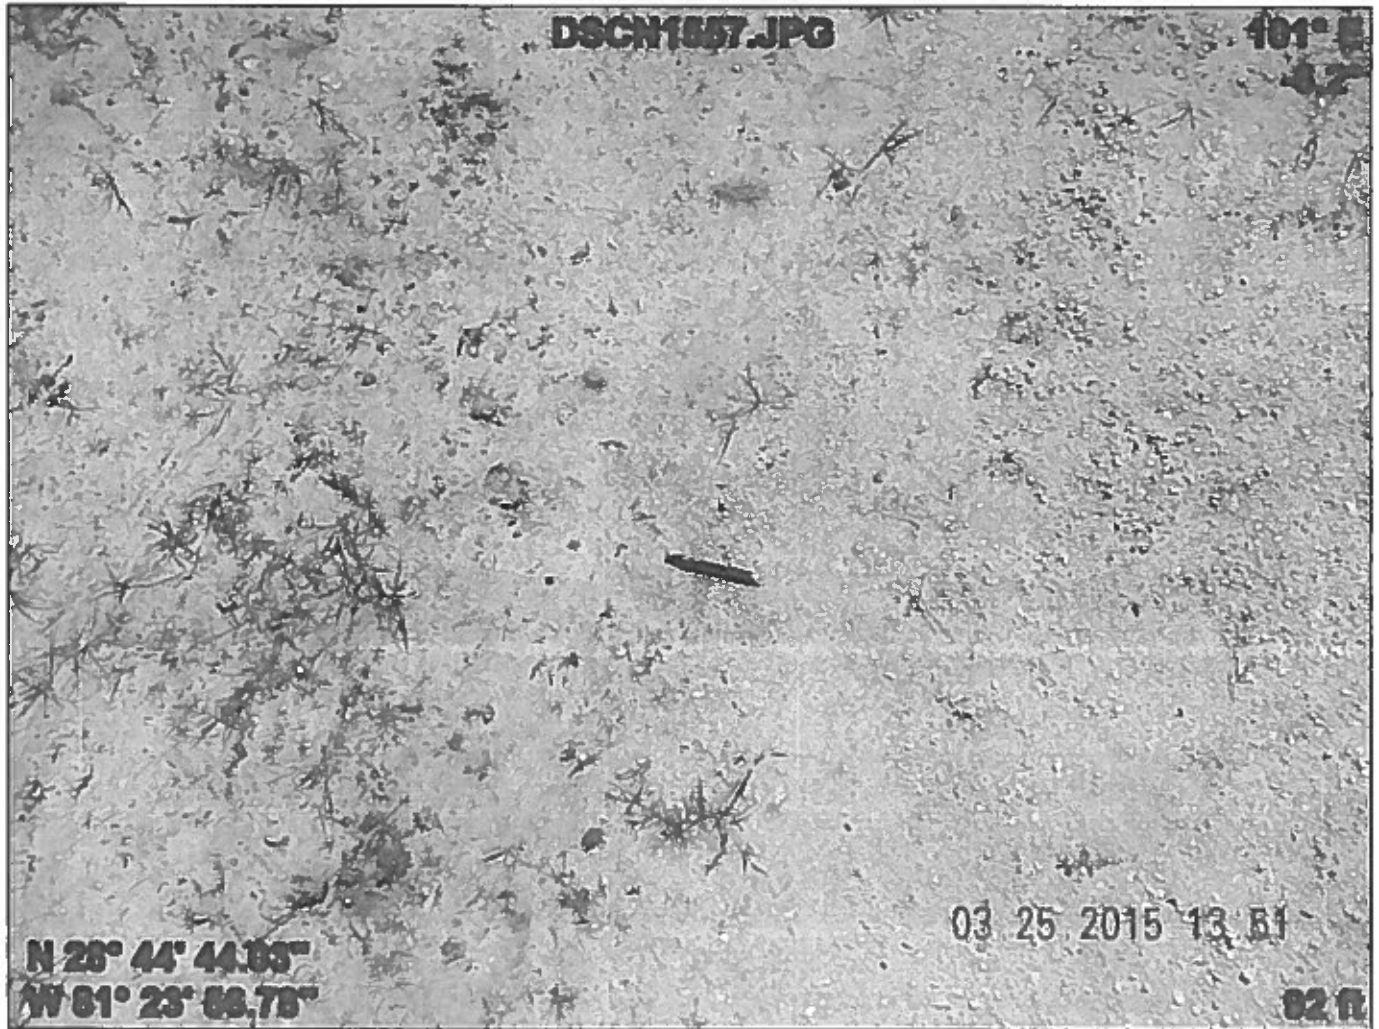
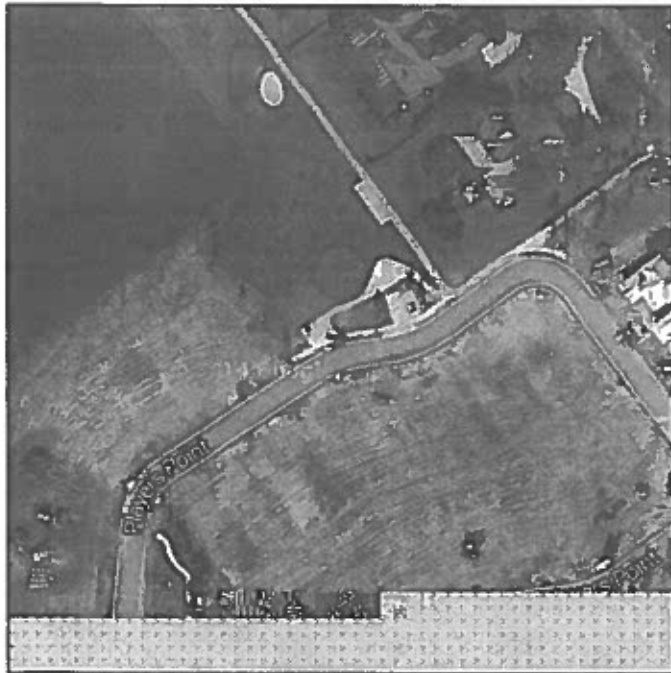
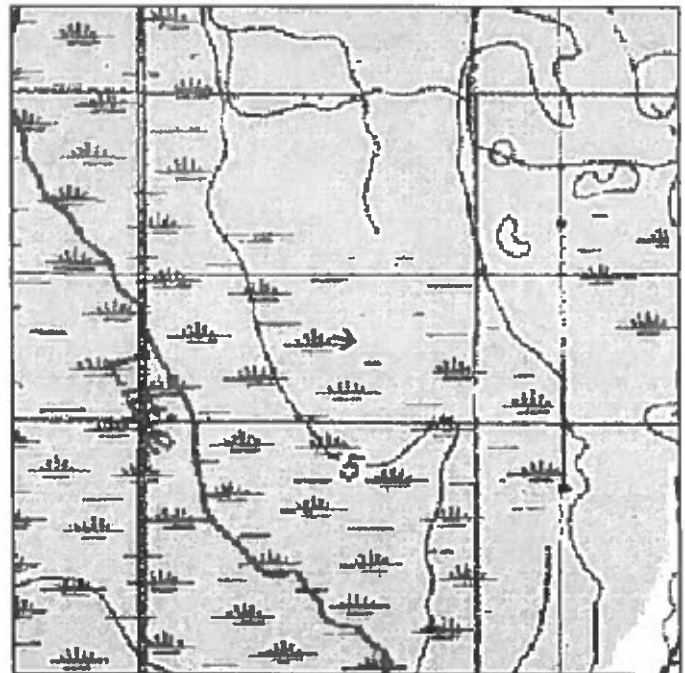
Description: close up of un-stabilized area at Lot #19.
